# BELZONA RESOLVES LEAKY LEAD ROOF AT UNIVERSITY

ID: 3012

Customer Location: University, Manchester, UK.  
Application Date: December 2011

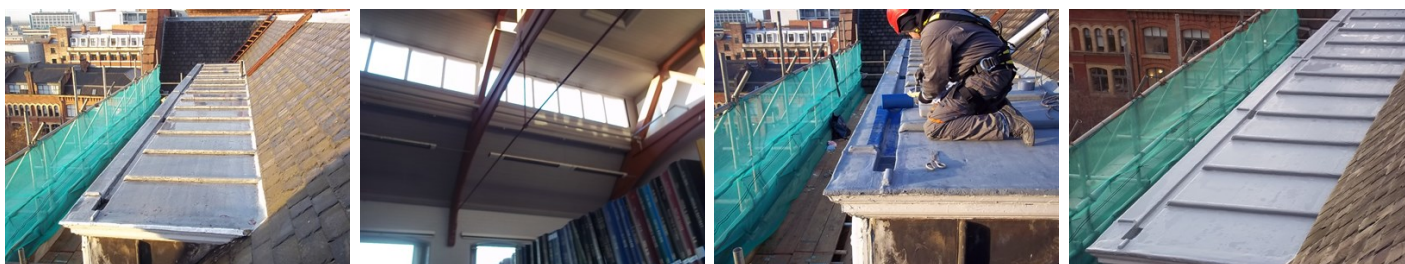
The three lead roofs were allowing water ingress into the wooden panelled ceiling below, under which there was office equipment and a library area. The client required urgent action to make the roofs water tight while not detracting from the lead roof aesthetics.

- \* Initial inspection of the lead dormer roofs ,
- \* View of the ceiling below the lead roof area ,
- \* Application of the reinforced Belzona® 3131 in progress ,
- \* Completed application ,

The application was carried out in accordance with Belzona Know-How System Leaflets RPA-1 and RPA-8

The client required an urgent solution to the problem as the winter weather was approaching and the water ingress issues were expected to deteriorate further. Replacement of the lead would have been very costly and time consuming. Belzona were able to provide a solution that was cost effective, aesthetically pleasing and in keeping with original lead appearance. The system was applied by a Belzona approved and IRATA trained rope access contractor. The work was successfully completed in 8 days and at around one third the cost of replacing the lead.
