# BELZONA REPAIRS DAMAGED CONCRETE IN PRIMARY SCHOOL PLAYGROUND

ID: 3032

Industry: *Buildings & Structures*  
Application: *FPA-Floor Problem Areas*  
Substrate: *Concrete / Cement*  
Products: *\* Belzona® 4131 (Magma Screed) ,*

Customer Location: *Derbyshire UK*  
Application Date: *December 2009*

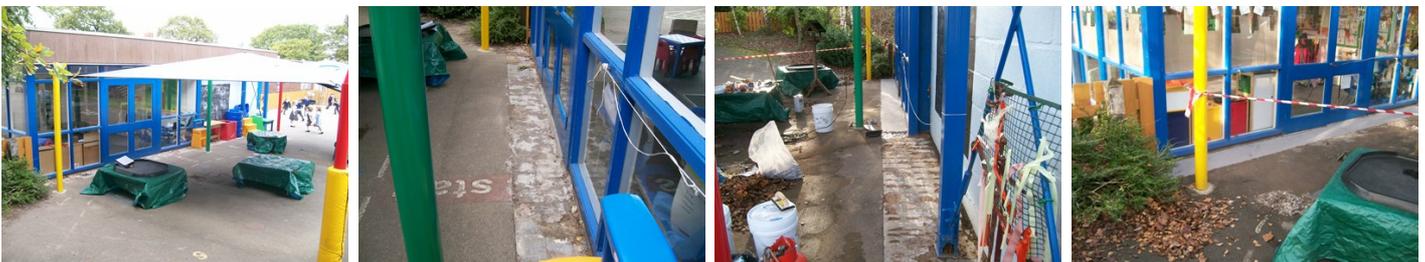
*Some loose and damaged tiles had been removed in the playground bordering a class room. This had left concrete exposed and the area looking unsightly and representing a potential slip/trip issue for young children.*

- \* The school play/activity area ,
- \* The damaged area to be repaired ,
- \* Belzona® 4131 repair in progress ,
- \* Completed application ,

An area of damaged and exposed concrete within a Primary School external play area.

The application was carried out in accordance with Belzona Know-How System Leaflet FPA-1

School required a quick and permanent solution to the issue. Traditional concrete/cement solutions were not appropriate as the bond strength would not be sufficient and it would be likely to shrink and crack creating additional problems. Hot work was out of the question and any products that would leave oily residue that could contaminate the children and their clothes were also not acceptable. Belzona® 4131 was chosen for its high bond strength, quick cure, high abrasion and impact resistance. Its ability to be

feather edged ensured it was flush with adjacent areas to the repair. The work was completed in one day and to the complete satisfaction of the school who asked us to return to repair a similar problem in another area of the playground.
