# BELZONA UPGRADE TO LARGE TRANSFORMER

ID: 3090

Customer Location: Power plant, North of France  
Application Date: January 2012

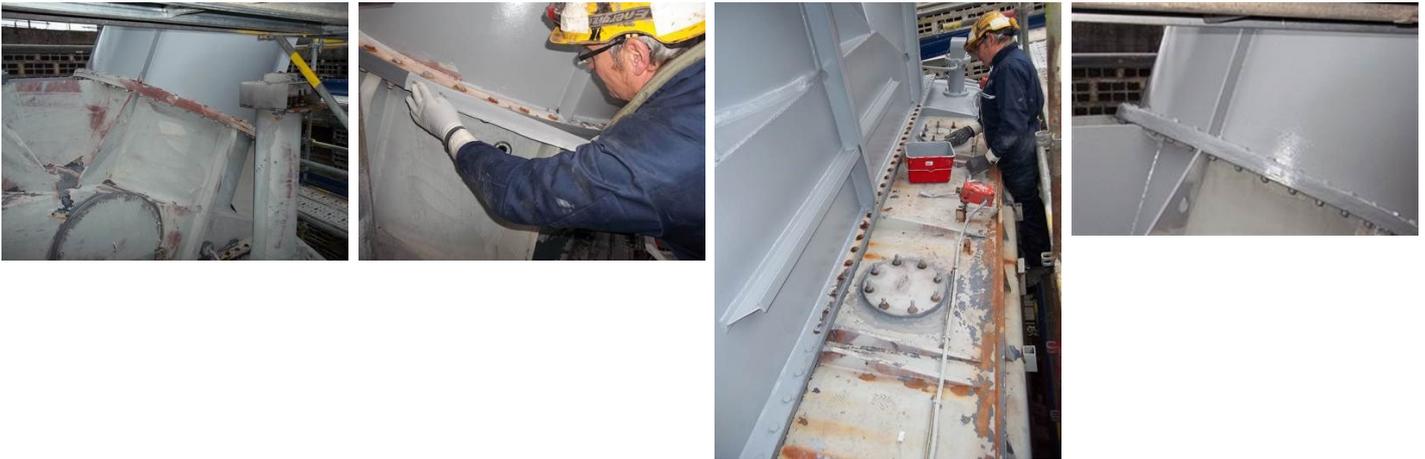
Oil was leaking from many of the flanges. Replacing the seals was not an option. This would have required draining the 42 tonnes of oil from the transformer as well as individually dismantling the 70 flange faces, a very time-consuming task.

- \* Original condition of the flange faces ,
- \* Repair with Belzona® 1161 and Belzona® 9341 ,
- \* Belzona being applied to encapsulate the bolts ,
- \* Finished application. ,

Application was carried out in accordance with Belzona Know-How System Leaflet VPF-11a.. After the surface was prepared using an MBX Bristle Blaster followed by degreasing the substrate, Belzona® 1161 and Belzona® 9341 (Reinforcement tape) were applied onto the whole surface of the flange faces in order to stem the leaks.

Belzona offered a cost-effective solution to the client to cold-seal the leaking flange faces without the need to drain down the oil. The application only took two weeks to complete, far less than the alternative of replacing the seals, and allowed a quick return in service of the transformer.
