# BELZONA SEALS TRANSFORMER LID FLANGE

Customer Location: Gas Distributor, UK  
Application Date: 2011

Lid gasket flange on this 66-11Kv transformer.

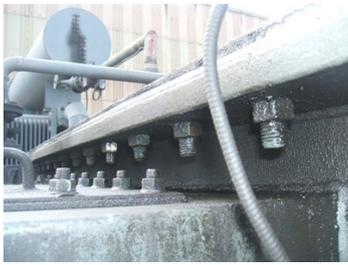
Most of the gasket had failed around the 10m perimeter of the lid, with oil seeping down the sides and going to ground. Unfortunately it was not possible to drain the oil below the gasket level and so the application had to be pursued as a live leak with a 1m head pressure.

- \* Original condition of flange with header tank at rear ,
- \* Encapsulation of bolts with Belzona® 1161 ,
- \* Completed repair close up ,
- \* Finished work after 3 days ,

Application was carried out using Belzona Know-How System Leaflet VPF-11 as a guide. Area of flange and bolts were pressure cleaned and grit blasted. Live leaks stemmed with Belzona® 1291 and Belzona® 1221. Bolt heads top and bottom were encapsulated with Belzona® 1161. Belzona® 1161 and Belzona® 9341 used to create a reinforced band around the flange. Finally over coated with Belzona® 5831.
