# BELZONA PROTECTS CONCRETE FROM 50% CAUSTIC SOLUTIONS

**Industry:** General Industry  
**Application:** TCC-Tanks and Chemical Containment Areas  
**Substrate:** Concrete  
**Products:** \* Belzona 5891 (HT Immersion Grade) ,

**Customer Location:** Textile Company, São Paulo, Brazil  
**Application Date:** January 2012

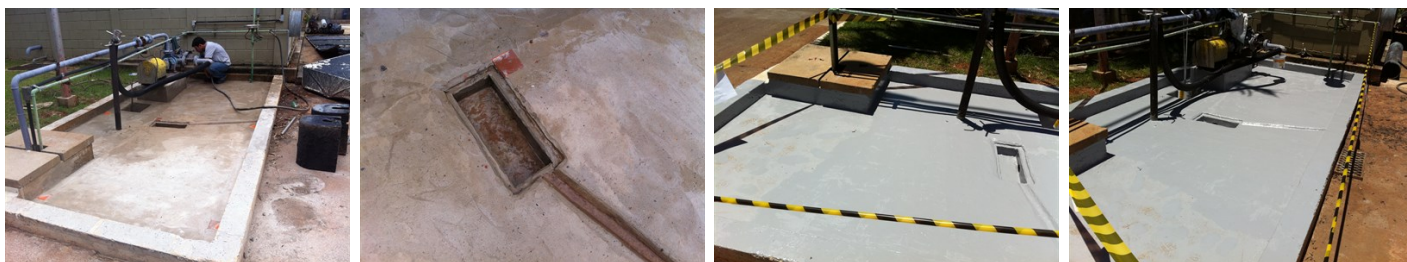
## Photograph Descriptions

50% Caustic solution containment area coating had failed and needed re-coating.

- \* Area to be coated. ,
- \* View of drain. ,
- \* Coating of Belzona 5891. ,
- \* Completed application. ,

The application was carried out in accordance with Belzona Know-How System Leaflet TCC-15. Concrete was rebuilt and application of Belzona 5891 was complete with one coat.
