# BELZONA PROTECTS NEWLY CONSTRUCTED PLANT ROOM

ID: 3419

**Customer Location:** University, Wolverhampton, UK  
**Application Date:** May 2012

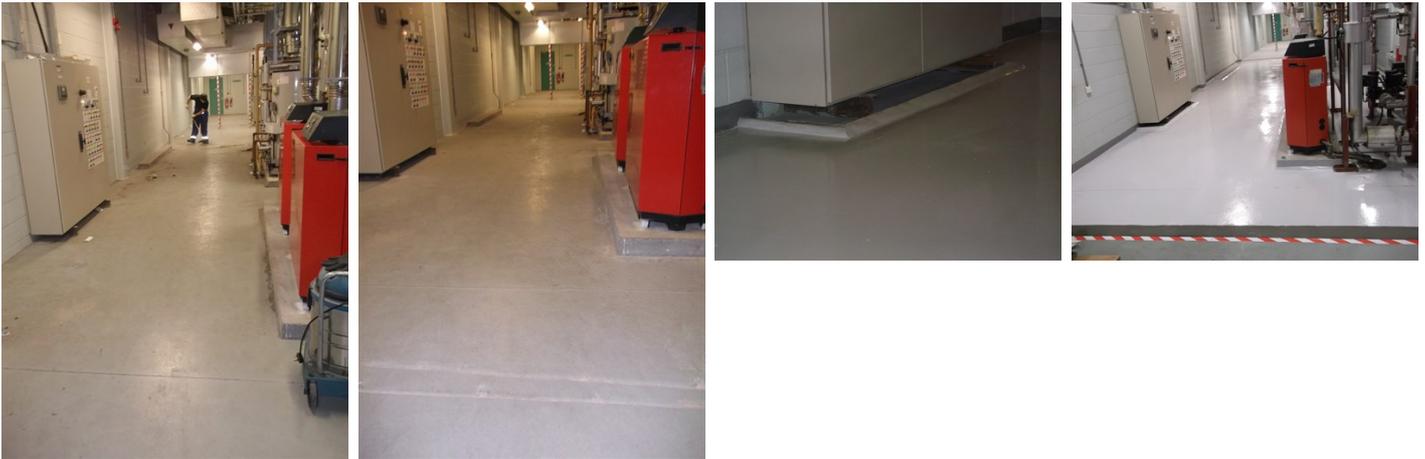
- \* Clearing of plant room floor ,
- \* Floor abraded in preparation for Belzona® 4131 bund and fillets ,
- \* Section of banded area ,
- \* Completed plant room floor bund after coating with Belzona® 5231 ,

Application was carried out in accordance with Belzona System Leaflets FPA-3 and TCC-15. Belzona® 4131 was used to create raised banded areas and covings before applying Belzona® 5231 to completely seal the floor area.

The customer had already experienced floods in other unprotected plant rooms and knew Belzona would be able to create the necessary protection required. The Belzona® 4131 enabled the construction of a raised containment area for spills for sealing with the impermeable Belzona® 5231. This coating has the added benefit of containing a non-slip aggregate improving the safety of the plant room when floor is wet.
