# THORDON BEARING GLUED IN PLACE WITH BELZONA

Application: SHM-Solids Handling Machinery

Customer Location: Hydro power station, Sweden

Replacement of one of the main turbine bearings.

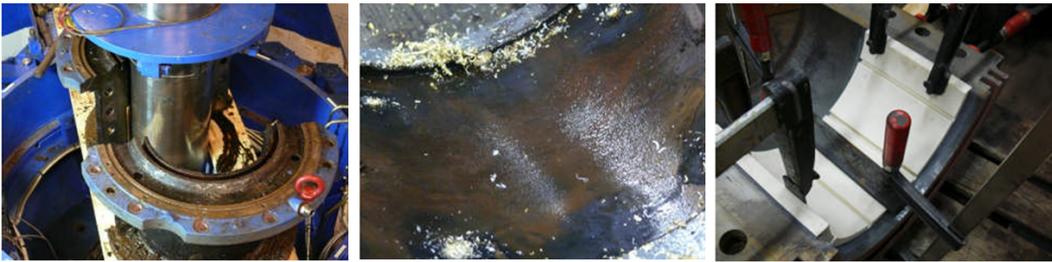
The original bearing was worn out and in need of replacement. The client was looking for effective solution to bond the bearing in place.

- \* Dismantling the bearing housing on the turbine ,
- \* The damaged bearing had disbonded from the bearing housing which resulted in a corroded surface ,
- \* Thordon SXL bearing half mounted and glued with Belzona® 1321. Clamps are used to hold bearing in position ,

Application was carried out using a modified version of Belzona Know-How System Leaflet SHM-7. After grit blasting the bearing housing, Belzona® 1321 was applied to the bearing housing and Thordon SXL bearing before clamping into place until cured. Finally, the bearing was machined down to the correct inner diameter.
