# PROTECTION OF DISTRICT HEATING SYSTEM

ID: 3430

**Industry:** Power  
**Application:** VPF-Valves, Pipes and Fittings  
**Substrate:** Steel  
**Products:** \* Belzona® 5851 (HA Barrier),  
\* Belzona® 5841,  
\* Belzona® 5831 (ST Barrier),

**Customer Location:** Electricity utility, Sweden  
**Application Date:** September 2009

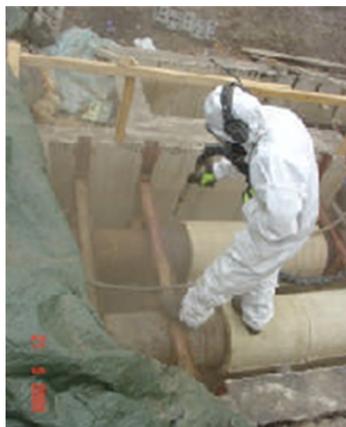
Corrosion on feed and return pipes as well as on supporting steelwork. System is in continuous use so products capable of application to hot surfaces required.

- \* District heating Chamber before renovation ,
- \* Dry ice blasting ,
- \* Coating being applied ,
- \* The finished application ,

Application was carried out in accordance with a modified version of Belzona Know-How System Leaflet VPF-2. Initially dry ice blasting was done to remove soil, oil and loose corrosion. Then two coats of the products were applied; Belzona® 5831 to supports and drainage pipe, Belzona® 5851 to feed-pipe & Belzona® 5841 to return pipe.
