# BELZONA STABILIZES GAS PIPELINE ON BRIDGES

ID: 3541

Customer Location: Gas transmission company, Slovakia  
Application Date: First repair in 1998

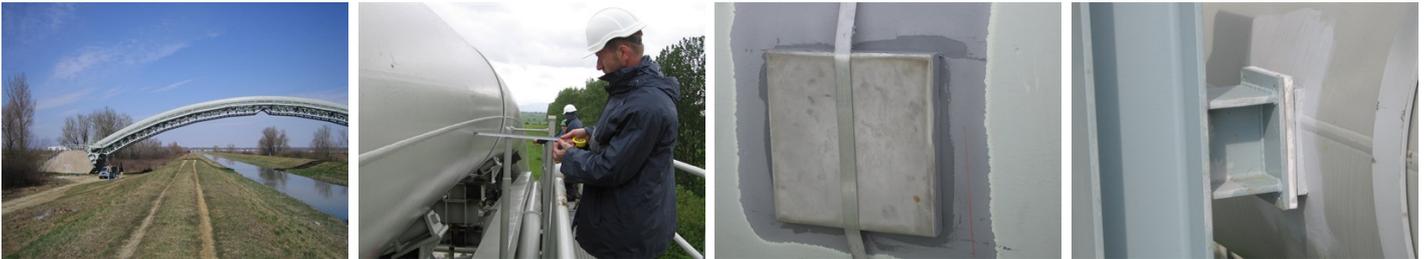
Customer needed to keep pipe line in fixed position. To achieve this several sliding supports between bridge and pipe had to be installed. Welding was not possible as gas line was active. Each bridge has 16 such supports.

\* General view of pipe bridge Preparing/measuring location for supports Belzona® 1111 used to bond wear pad Completed sliding support in place. ,

Repairs were completed in accordance with Belzona Know-How System leaflet VPF-15.

Every support is "connected" with pipe line via the slide assembly. The slide assembly needed to be fixed to the pipeline. Belzona® 1111 provides high strength bond without the need for hotwork, allowing work to progress without disrupting gas supplies. Since 1998, 5 such bridges have had supports bonded with Belzona without a single problem in that time.
