# COLD BONDING WITH BELZONA OFFERED ALTERNATIVE REPAIR TO PENSTOCK

ID: 3617

Customer Location: Hydro Power station, UK  
Application Date: March 2006

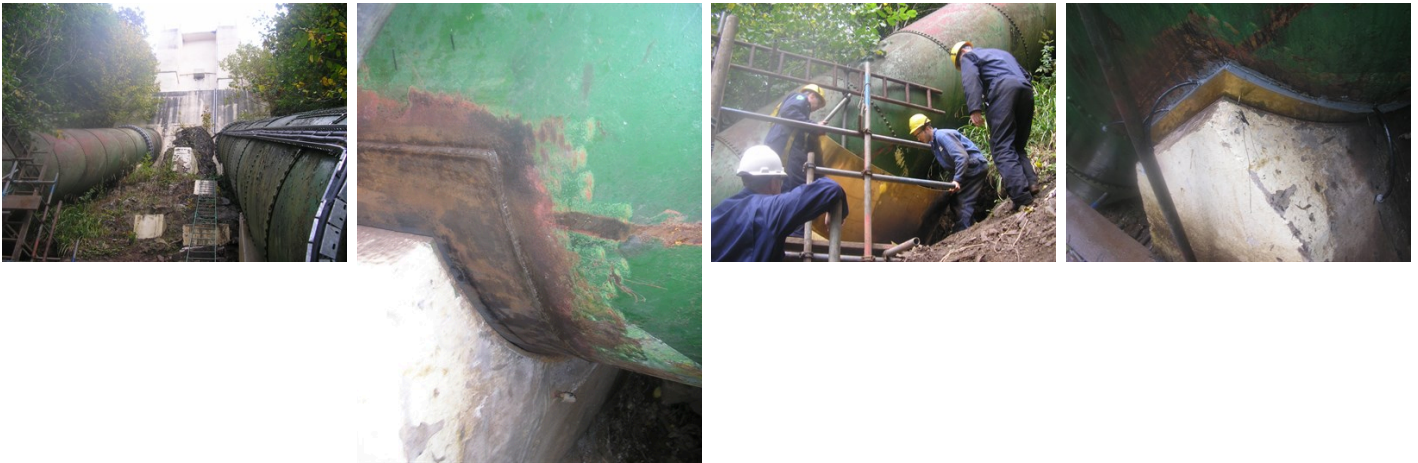
The penstock had been weld repaired and due to the nature of hot works, the penstock had deformed and created a void between the penstock pipe and the concrete support pad. The Hydro power station would not accept the void between penstock and the pipe support and informed the contractor they would need to rectify the problem before signing the job off.

- \* View of the penstock ,
- \* View of the pipe support 3. Brass plate being put into place ,
- \* Application completed (Belzona® 1211 on the edges, Belzona® 5811 injected in the void) ,

Application was carried out in accordance with Belzona Know-How System Leaflet GSS-9. Edges of brass plate were sealed to penstock with Belzona® 1211. Void between penstock and plate was then filled with Belzona® 5811 using injection equipment.

The repair was done on site, in a short time. The injection technique used in this application ensured that there is no void between the brass plate and the penstock, eliminating any galvanic or crevice corrosion. Belzona application remained effective until entire penstock had to be replaced.
