# BELZONA LEADING EDGE SOLUTION FOR WICKET GATES

ID: 3618

**Customer Location:** Turbine manufacturer, France.  
**Application Date:** June 2009

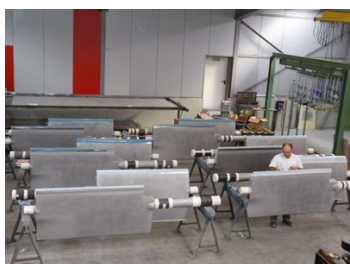
*Due to the operating environment, wicket gates suffer from corrosion and abrasion on the leading edge, due to entrained solid particles in the water.*

- \* View of the wicket gates after blasting ,
- \* Belzona® 1341 applied to offer erosion corrosion protection ,
- \* Belzona® 2121 applied to offer impact resistance ,
- \* View of the wicket gates completed ,
