# BELZONA SECURES "A" BRACKETS TO YACHT HULL

ID: 368

Industry: *Marine*  
Application: *SOS-Ships and Offshore Structures*

Customer Location: *Luxury Yacht Builder in UK*  
Application Date: *September 2000*

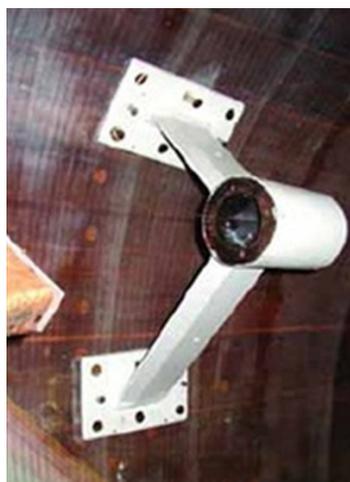
*Irregular shim required to ensure long term, stress-free attachment to curved GRP clad surface. Underlying hull is timber and steel.*

- \* Bracket positioned using aligning wire and jacking bolts ,
- \* Belzona® 1121 being injected between hull and bracket ,
- \* Completed application ,

The Belzona provides a high-strength irregular shim under "A" brackets ensuring no stress points on the hull. Non-slump properties

of the Belzona important as gaps to be filled ranged from 3 to 25mm (1/8" to 1")
