BELZONA PROTECTS OPEN DRAINS TANK

ID: 385

Industry: Oil & Gas
Application: TCC-Tanks and Chemical Containment Areas

Customer Location: North Sea gas producer
Application Date: 2003

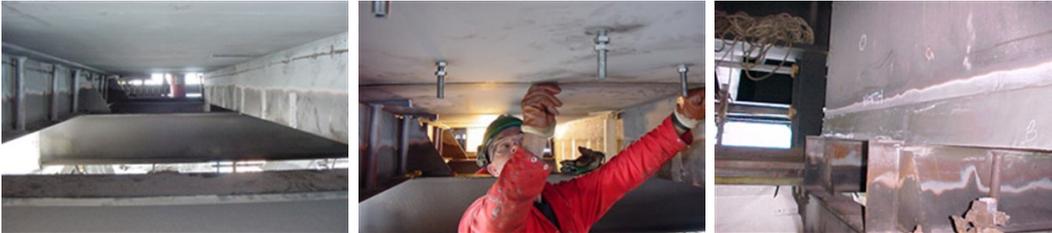
Due to the location of the tank it is subjected to a salt environment which accelerates corrosion externally as well as internal corrosion from the process chemicals.

- * Front view showing Belzona product ,
- * Side view ,
- * Sealing of tank base seams using Belzona® 1111 ,

The tank base was grit blasted and plates were secured in position using Belzona® 1111 and held in place using chocks. Once the Belzona® 1111 had been allowed to cure, Belzona® 5811 was injected into the gap between the plate and the tank base. In addition all of the tank nozzles were wrapped using Belzona® 1111 / 9341 along with all of the tank base weld seams from the tank side/base joint. Following this the new tank base and sides were coated with Belzona® 6111 / 5111 for future corrosion protection.
