BELZONA BONDS SUPPORT PADS AND RAILS

ID: 402

Customer Location: Refinery - Brazil
Application Date: November 2001

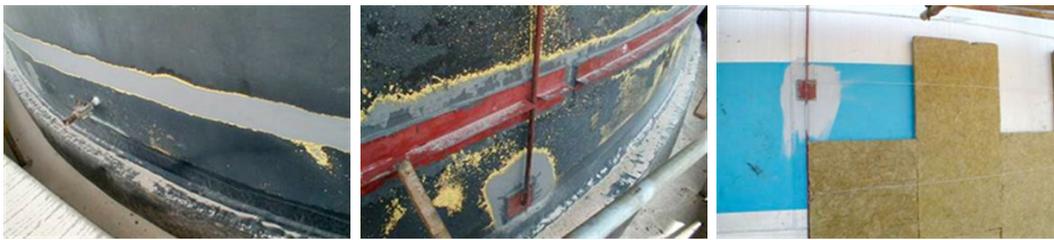
Photograph Descriptions

- * Surface preparation consisted of blasting the exterior metal surface of the tank. ,
- * Soon thereafter, the pads and rails were installed using the Belzona® 1111. ,
- * The thermal insulation pads are being installed, using the rails as support members. ,

Bonding of support pads and rails.

Application was carried out in accordance with a modified version of Belzona Know-How System Leaflet TCC-3.

Rails and support pads had to be installed to serve as a support structure for the thermal insulation pads. Ten more tanks have been completed since this initial application.
