Belzona provides high temperature corrosion protection in vessel

ID: 4046

Industry: Oil & Gas
Application: TCC-Tanks and Chemical Containment Areas
Substrate: Steel
Products: * Belzona 1591 (Ceramic XHT Metal),

Customer Location: Egypt
Application Date: 2004

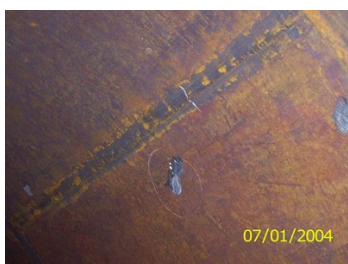
Internal lining required for vessel processing high temperature hydrocarbons and water

- * 1. Corroded surface ,
- * 2. Surface after preparation ,
- * 3. Application process ,
- * 4. Completed application ,

This application was carried out in accordance with TCC-3. After surface preparation by grit blasting the two coats of Belzona 1591 were applied.
