AN UPLIFTING BELZONA SOLUTION

ID: 407

Customer Location: Refinery - Brazil
Application Date: August 2003

Relocation of two 22-ton riveted storage tanks.

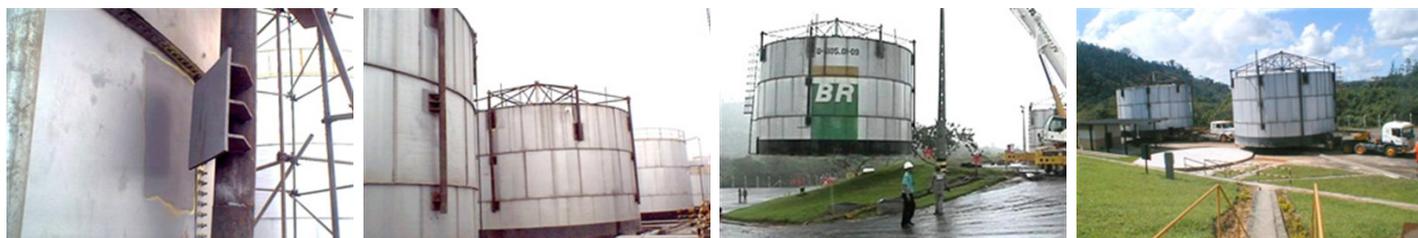
Photograph Descriptions

- * View of the metal pad to be bonded against the exterior wall of the tank. ,
- * View of the tanks, each with pads bonded in place, along with the upper support structure installed ,
- * One of the tanks being lifted with a crane ,
- * The tanks were moved 200 meters and 15Km respectively ,

The Belzona Technical Consultant, the end-user and an engineering company all became involved in devising the correct procedure with which to move the two tanks. Sixteen metal pads were bonded to each tank. A metal support structure was erected so as to prevent the walls from collapsing. Calculations of the mechanical properties of Belzona® 1111 revealed that by carrying out the application as planned that 420 tons could be supported. This presented a safety margin of approximately 1,170%.
