# BELZONA SOLVES LEAKING SCHOOL ROOFS

ID: 4129

Application: RPA-Roof Problem Areas

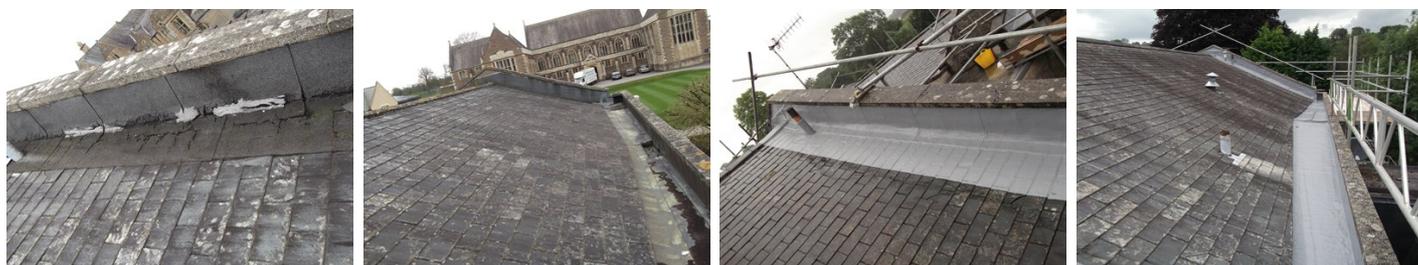
Asphalt, used to replace lead flashings in gutters, had failed allowing water ingress into the four boarding house buildings. Several attempts to repair the asphalt had failed. The school required a solution to be cold applied so allowing them to remain in use.

- \* Asphalt replacement of lead flashing showing heavy UV degradation and breakdown ,
- \* View of roof showing gutter and asphalt replacement of lead flashing ,
- \* Belzona® 3131 successfully applied to area of flashing where substrates are slate, asphalt & stone ,
- \* Finished Belzona® 3131 application to gutters and flashing. ,

The application was carried out in accordance with modified versions of Belzona Know-How System Leaflets RPA-6 & RPA-8.

The Belzona solution was carried out over two weeks. Belzona® 3131 bonding to all of the substrates meant that the old asphalt did not require complete removal which could have led to damage to the slate tiles. The results were a complete success allowing the school continued use of the boarding houses. To replace the damaged asphalt with traditional lead work would have been over budget & involved hot work stopping the use of the boarding houses & the summer school events.
