BELZONA WATERPROOFS NATURAL STONE FACADES

ID: 4204

Customer Location: *Private Building, Amman, Jordan*
Application Date: *November 2012*

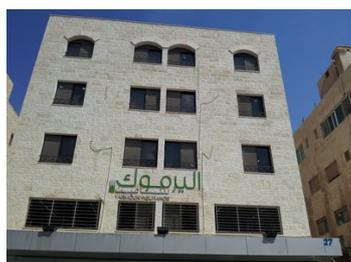
Water was penetrating the stones, creating damp areas on internal walls. The owner of the building needed to waterproof the structure and retain the natural appearance of the stones.

- * Front view of the building before application ,
- * Front view of the building after sand blasting ,
- * Applying Belzona 5122 with spray unit ,
- * Front view of the building after finish of application ,
