BELZONA PROTECTS CHEMICAL VESSELS FROM NEW

ID: 421

Industry: Chemical & Petrochemical
Application: TCC-Tanks and Chemical Containment Areas
Substrate: Steel
Products: * Belzona® 4311 (Magma CR1) ,

Customer Location: Chemical Plant in Italy
Application Date: September 2001

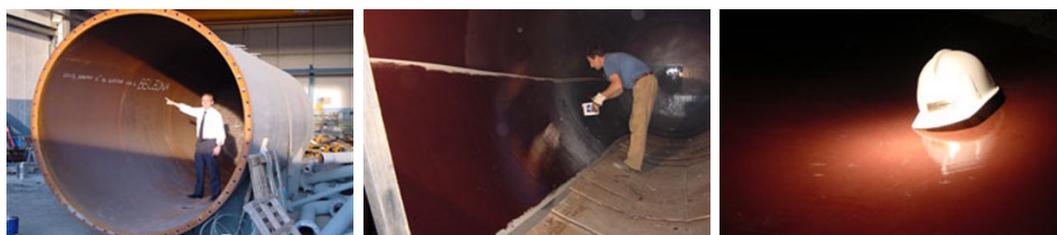
Photograph Descriptions

- * The vessel before preparation. ,
- * Belzona® 4311 being applied. ,
- * The completed application was like a work of art! ,

Vessel containing a mixture of Toluene, Benzene and other aromatic fluids in water at ambient temperature.

Application was carried out in accordance with Belzona Know-How System Leaflet TCC-3. In order to ease application, the vessel was rotated to remove the need for overhead work.
