IMITATION IS A RISKY BUSINESS

Application: *SHM-Solids Handling Machinery*

Customer Location: *Cement company, Philippines*

Products: *Belzona® 1812 (Ceramic Carbide FP)*

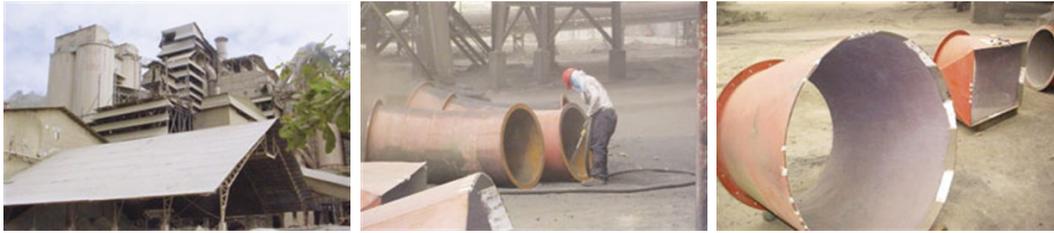
Photograph Descriptions

Coal cyclone wears out fast due to abrasive action of coal particles at high velocity and temperatures of around 100°C.

1. View of the cement facility.

2. Agresive blasting surface preparation in process.

3. Belzona® 1812 applied.

Application was done in accordance with Belzona Know-How System Leaflet SHM-8.

Field and test results have shown that Belzona® 1812 has excellent wear resistance against abrasive action of coal particles. The cyclone previously was coated with other imitators but those have worn quickly away.
