# BELZONA MAKES MESSY JOB EASY CLEAN

ID: 4243

Industry: General Industry  
Application: VPF-Valves, Pipes and Fittings  
Substrate: Steel  
Products: \* Belzona® 1341 (Supermetalglide) ,

Customer Location: Construction company, Toronto, ON  
Application Date: May 2012

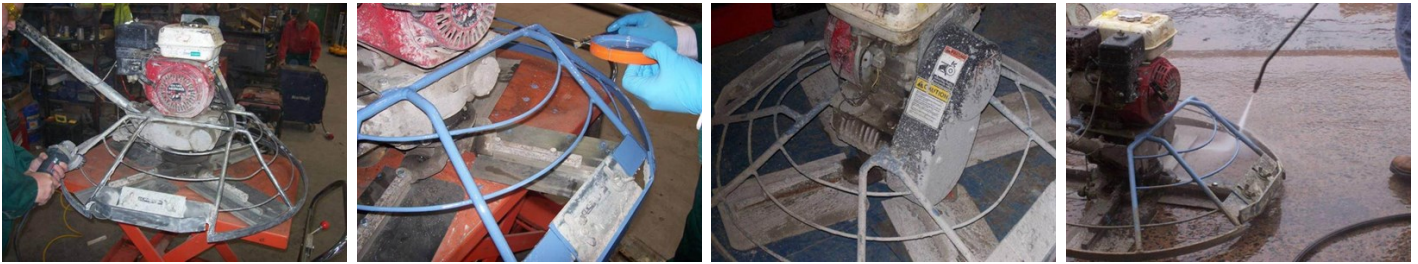
## Photograph Descriptions

It takes someone about an hour with a power washer, hammers, and wire brushes to clean this before the next use. Frequent re-painting of the guard is required as the cleaning process also remove the paint.

- \* Surface preparation ,
- \* Brush Application of Belzona® 1341 ,
- \* After application and first usage ,
- \* Simple cleaning with power washer ,

During the use of the power floater the rotary guard gathers a lot of concrete that dries on.

Application carried out in accordance with Belzona Know-How System Leaflet VPF-2

The application of Belzona® 1341 has reduced cleaning time by 900-1200%. It now takes just 5 minutes and only requires a power washer!
