BELZONE EFFECTS EMERGENCY REPAIRS TO LEAKING SWIMMING POOL

Customer Location: Public swimming pool, British Columbia, Canada

Application: FPA-Floor Problem Areas

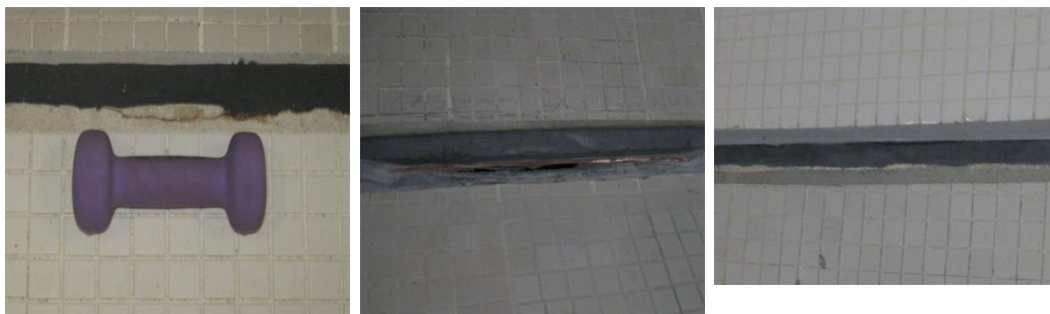
Photograph Descriptions

Vibration from the use of a "jackhammer " by a contractor in the pool basin to expose leaking pipes had caused cracks to develop in the concrete grout forming the edges of this pool's unique expansion joint system. Dye testing located 12 separate leaks.

- * The grout used to form the expansion joint sides, and the crack in it, are visible above the hand weight used to mark leak locations during dye testing ,
- * The void beneath the crack is exposed ,
- * The joint repaired. Twelve separate leaks were isolated and sealed ,

Application was carried out in accordance with Belzona Know-How System Leaflets FPA-5 & FPA-6. Cracked grout was removed and joint edges rebuilt with Belzona® 4111, followed by repair with Belzona MP Elastomer of the expansion joints in affected areas.

The emergency Belzona repairs were completed over a period of two days and the pool was re-opened to the public one week after the Belzona repairs had been completed. Leakage was found to be even lower than before the initial problem had arisen.
