BELZONA® 3211 (LAGSEAL) PREVENTS FUTURE UNDER INSULATION CORROSION

ID: 425

Customer Location: *Cement manufacturer - Tunisia*
Application Date: *February 2004*

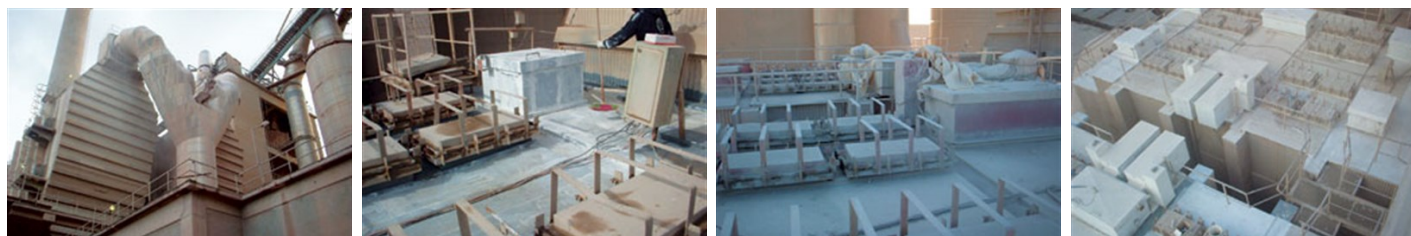
Photograph Descriptions

The Electrostatic precipitators at this large cement manufacturer operate at 70kv and 200°C (392°F). As a consequence they are insulated to conserve heat energy. As usual the insulation is protected by the use of jointed steel sheeting which does not prevent moisture from penetrating the insulation layer. The result is under insulation corrosion made worse by the fact that the site is coastal and the atmosphere is salt-laden.

- * View of precipitators ,
- * Work begins ,
- * View of precipitator's roof ,
- * Application complete ,

The insulation cladding is completely sealed with the Belzona® 3211(Lagseal) System. The entire surface except over the pressure relief valves of two of the four precipitators were protected and sealed with Belzona in six days. Each precipitator was nearly 300

square meters in size.
