SERVICE LIFE OF DREDGING FLUSH WATER PUMP EXTENDED WITH BELZONA

ID: 4287

Customer Location: Drydock, Bremen, Germany
Application Date: October 2008

Rubber-lined KSB flush water pump on North Sea dredger.

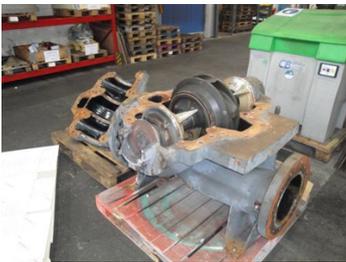
Extensive cavitation damage near impeller and high pressure areas. Cavitation and erosion had led to the pump casing's rubber lining being partly eroded. Further erosion damage was found on the casing.

- * Damaged rubber-lined pump ,
- * Close-up of one of the damaged areas ,
- * Damage rebuilt with Belzona® 1812 ,
- * Completed application with Belzona® 2141 Elastomer applied ,
