BELZONA PROTECTS CHIP CYCLONE WELD SEAMS

ID: 43

Application: *TCC-Tanks and Chemical Containment Areas*

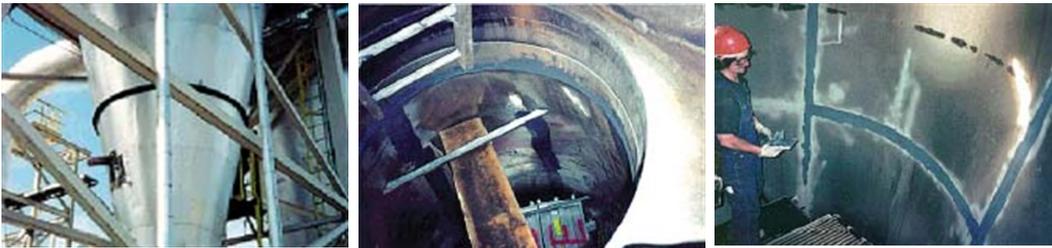
The chip cyclone suffers from continuous erosion, and the irregularities and/or protrusions of the weld seams were attacked.

- * Conical shaped chip cyclone. ,
- * Eroded weld seams of the chip cyclone. ,
- * Belzona® 1321 (Ceramic S-Metal) being used to protect weld seams from future erosion. ,

The Belzona® 1321 (Ceramic S-Metal) protected the weld seams for over two years, before a new unit arrived to replace the old chip cyclone.
