BELZONA PROTECTS PASSENGER FERRY JET TUBES

ID: 4343

Industry: *Marine*
Application: *SOS-Ships and Offshore Structures*

Customer Location: *Drydock, UK*
Application Date: *November 2012*

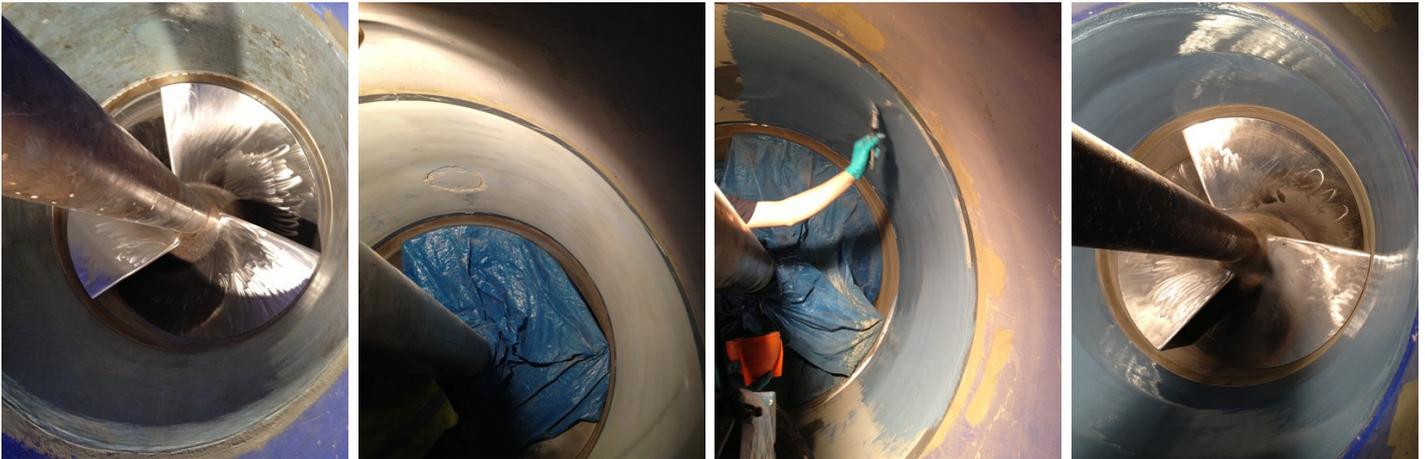
Photograph Descriptions

The jet tubes suffer cavitation due to the high flow rates through them.

* Existing Belzona 1341 still in good condition Flash blast over existing Belzona 1341 Top hat sections rebuilt with Belzona 1111 Belzona 1341 applied to complete the application ,

Application is carried out in accordance with Belzona Know-How System Leaflets SOS-1 & 2. After removing and replacing "top hat" inspection covers, Belzona 1111 applied to fair off before coating entire tube with Belzona 1341.

The application is an annual job that is performed while the ferry is in dry dock. Although most of the Belzona 1341 is intact, by applying an extra coat of Belzona 1341 over the existing Belzona coating the jet tubes are kept in full working service rather than waiting until a major failure.
