BELZONA PAVES THE WAY TO PARADISE

ID: 435

Customer Location: Florida Department of Transportation
Application Date: October - November, 2002

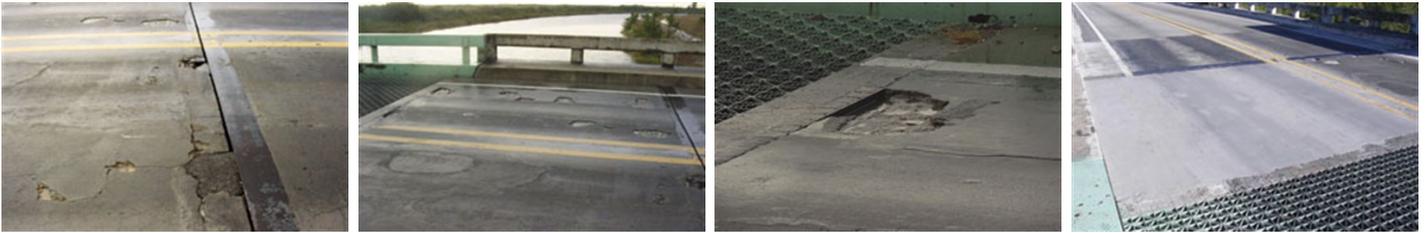
Photograph Descriptions

Bridge suffering from thermal cycling, heavy vehicular traffic and vibration, creating potholes and cracks.

- * 1. & 2. & 3. Show various trouble spots ,
- * 4. Ready for traffic ,

Other conventional repair methods failed in very short time. Belzona® 4151 was mixed with pea gravel. This provided a base layer of material in the cracks and potholes. This was then overcoated with Belzona® 4111. The application took place overnight to minimize traffic interruptions.
