# BELZONA PAVES THE WAY TO PARADISE

Application: *FPA-Floor Problem Areas*

Customer Location: *Florida Department of Transportation*

Bridge, Florida Keys

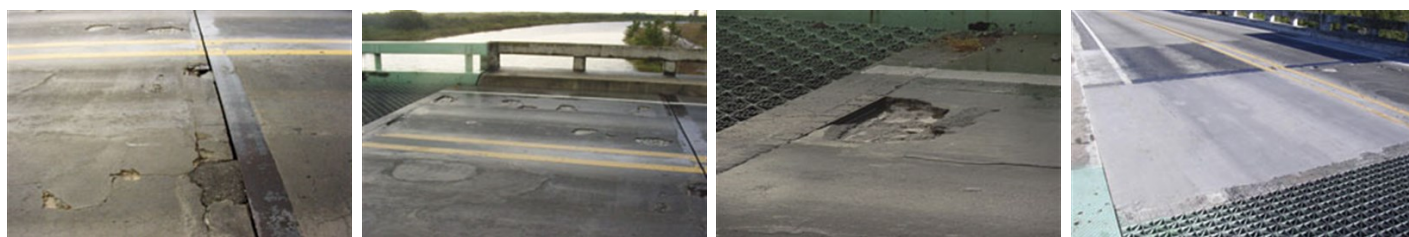
*Bridge suffering from thermal cycling, heavy vehicular traffic and vibration, creating potholes and cracks.*

- \* 1. & 2. & 3. Show various trouble spots ,
- \* 4. Ready for traffic ,

Other conventional repair methods failed in very short time. Belzona® 4151 was mixed with pea gravel. This provided a base layer of material in the cracks and potholes. This was then overcoated with Belzona® 4111. The application took place overnight to minimize traffic interruptions.
