NOZZLE STABILISATION AT ONSHORE GAS PLANT

ID: 458

Customer Location: Gas Processing Plant - UK

Application: VPF-Valves, Pipes and Fittings

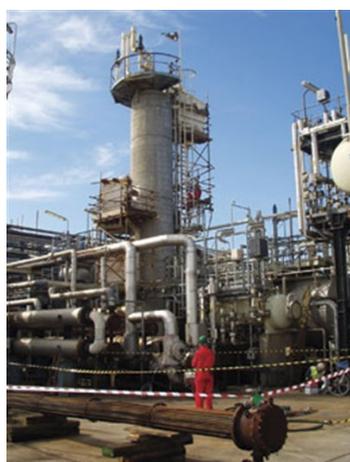
- * Gas stabilisation tower being sheeted ready for grit-blasting ,
- * CUI Corrosion damage to the neck of the nozzle ,
- * Completed application following injection of Belzona® 1391 and application of Belzona® 5111/6111 ,

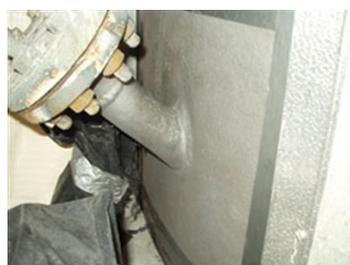
Under insulation corrosion had caused severe wastage of the neck of five nozzles on this gas stabilisation tower. As the vessel is manufactured to a strict code, any welding would have required extensive subsequent heat treatment.

A doubler assembly was manufactured from a curved plate and oversize pipe. This was then cut to allow easy assembly. The plate was then sealed and injected with Belzona® 1391 to act as an adhesive. Once completed the whole assembly was protected from further corrosion by application of Belzona® 5111 and Belzona® 6111. Application reported OK in February 2008 and many other similar applications carried out for the client.
