# BELZONA PROTECTS COAL DIRECTOR

ID: 461

Customer Location: Coal-fired Power Plant - Ontario, Canada

Coal director for pulverizer

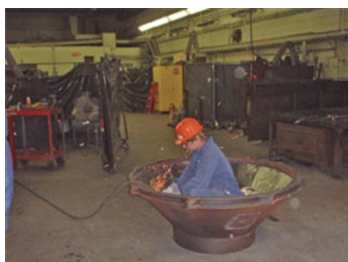
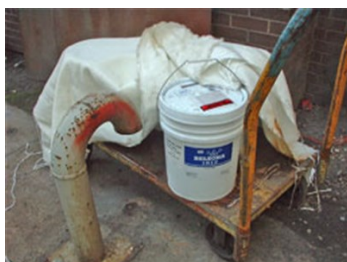
The steel plate on the coal director was worn through and in need of replacement.

- \* Surface preparation ,
- \* Product was kept warm with the help of this steam pipe ,
- \* Completed application ,

New steel was put in place. Steel was hand prepared and Belzona® 1812 material was put down with 1/8" thickness. This Belzona system provides excellent abrasion resistance, while ensuring the coal moves as required.
