# BELZONA PROTECTS COAL DIRECTOR

ID: 461

Customer Location: Coal-fired Power Plant - Ontario, Canada

Coal director for pulverizer

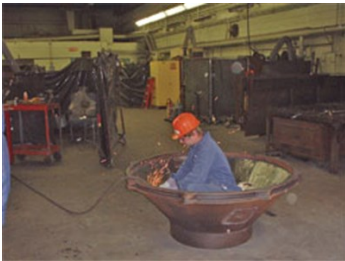
*The steel plate on the coal director was worn through and in need of replacement.*

- \* Surface preparation ,
- \* Product was kept warm with the help of this steam pipe ,
- \* Completed application ,

New steel was put in place. Steel was hand prepared and Belzona® 1812 material was put down with 1/8" thickness. This Belzona system provides excellent abrasion resistance, while ensuring the coal moves as required.
