# BELZONA PROTECTS COAL DIRECTOR

Application: SHM-Solids Handling Machinery

Customer Location: Coal-fired Power Plant - Ontario, Canada

Coal director for pulverizer

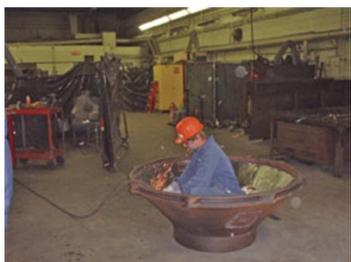
The steel plate on the coal director was worn through and in need of replacement.

- \* Surface preparation ,
- \* Product was kept warm with the help of this steam pipe ,
- \* Completed application ,

New steel was put in place. Steel was hand prepared and Belzona® 1812 material was put down with 1/8" thickness. This Belzona system provides excellent abrasion resistance, while ensuring the coal moves as required.
