BELZONA REPAIRS WASTE WATER SLUDGE TANKS

ID: 4647

Customer Location: Sludge treatment site UK
Application Date: May 2013

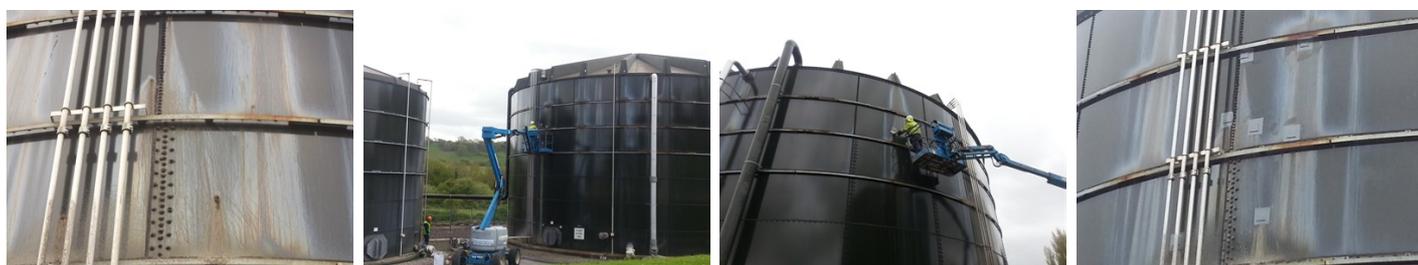
Photograph Descriptions

All three tanks were suffering from through wall corrosion at the vapour interface level. The tanks could not be taken off line due to demand and any repairs would have to be carried out without hot works or the use mechanical equipment due to the risk of sparks.

- * Original tank condition. ,
- * Plate bonding be carried out with Belzona® 1161 from cherry picker no scaffolding was required. ,
- * Final coating with Belzona® 5831 ,
- * Area of finished repairs. ,

The application was carried out in accordance with Belzona Know-How System Leaflet TCC-3. After cleaning the areas surface preparation by hand abrasion was carried out. Repair plates pre-coated with Belzona® 5831 were cold plate bonded over the through wall defects using Belzona® 1161 finally Belzona® 5831 was applied to the entire repair areas.
