# BELZONA PROTECTS HYDROELECTRIC DAM COMPONENT

ID: 4656

Customer Location: Brampton, Ontario, Canada  
Application Date: April 2013

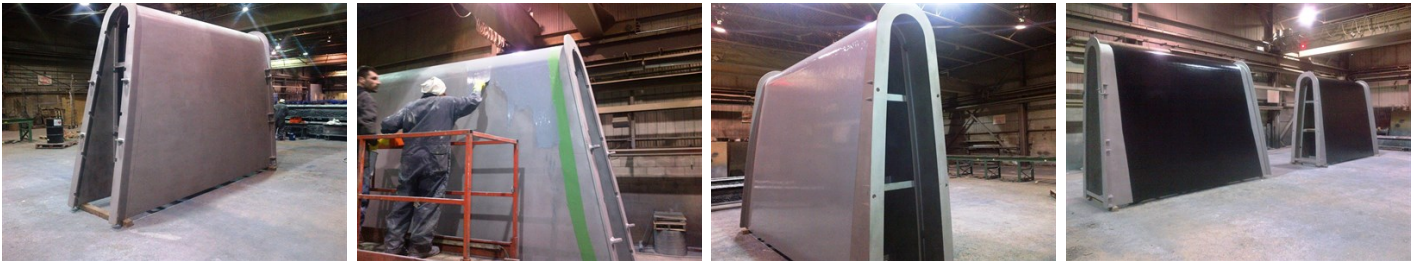
High volume of river water will flow over the steel component and client wanted a coating suitable for permanent immersion and to protect from corrosion.

- \* Abrasive blasted substrate awaiting coating ,
- \* Application of 1st coat of Belzona 5811 (Grey) ,
- \* Completed application of 1st coat of Belzona 5811 (Grey) ,
- \* Completed application of 2nd coat of Belzona 5811 (Black) ,

Application was carried out by brush in accordance with Belzona Know-How System Leaflet CEP-4
