BELZONA SAVES REFINERY FROM DAILY LOSSES OF £1.5M

Industry: Oil & Gas
Application: VPF-Valves, Pipes and Fittings
Substrate: Steel
Products: * Belzona 1221 (Super E-Metal) ,
* Belzona 1161 (Super UW-Metal) ,
* Belzona 4301 (Magma CR1 Hi-Build) ,

Customer Location: Petrochemical Refinery, UK
Application Date: June 2013

Flare line at refinery.

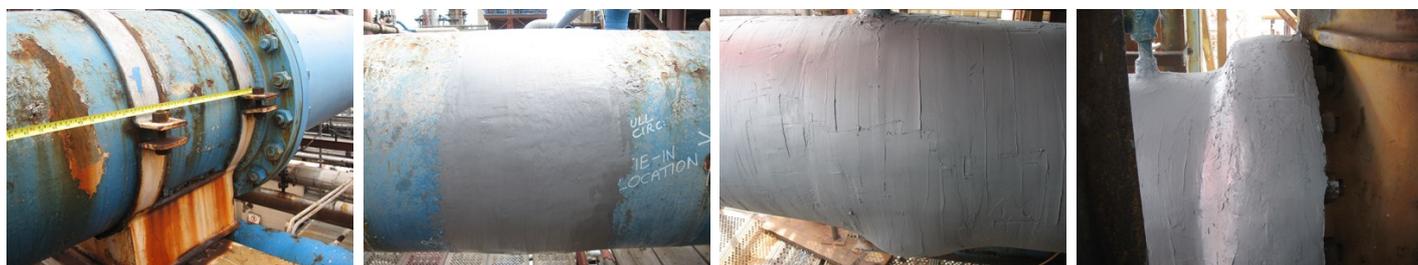
Photograph Descriptions

Severe external corrosion had reduced wall thickness. The client required a fast solution to this problem with minimal service disruption. After all, every day of shutdown was costing them £1.5 million.

- * Corroded and pitted pipework ,
- * Temporary wrap over holed area ,
- * Application of chemical resistant wrap ,
- * Final wrap and flange encapsulation ,

The application was carried out in accordance with Belzona Know-How System Leaflet VPF-11. The application team worked on live equipment, hence shutdown was not necessary. Where leaks were present, a plate was bonded using Belzona 1221 over a holed area. A temporary wrap was created around that area using the same material. Then the whole pipe was wrapped using Belzona 4301. Belzona 1161 wrap was applied on top and also used to encapsulate the adjacent flange.

This composite system was chosen so that any subsequent through wall corrosion in the pipeline caused by the internal acidic gases

would initially meet Belzona 4301, which has excellent acid resistance. Belzona 1161 in turn adds mechanical strength, while at the same time protecting the pipework from external damage. The Belzona solution was applied online, hence a shutdown estimated to cost the refinery £1.5M/day was not required. The application only took 3 days to complete.
