# BELZONA® PROVIDES LONG-TERM PERFORMANCE IN BRIDGE JOINTS

Industry: *Buildings & Structures*  
 Application: *FPA-Floor Problem Areas*  
 Substrate: *Concrete and steel*  
 Products: *\* Belzona® 4521 (Magma-Flex Fluid) ,*

Customer Location: *Department of Transportation, USA*  
 Application Date: *2005*

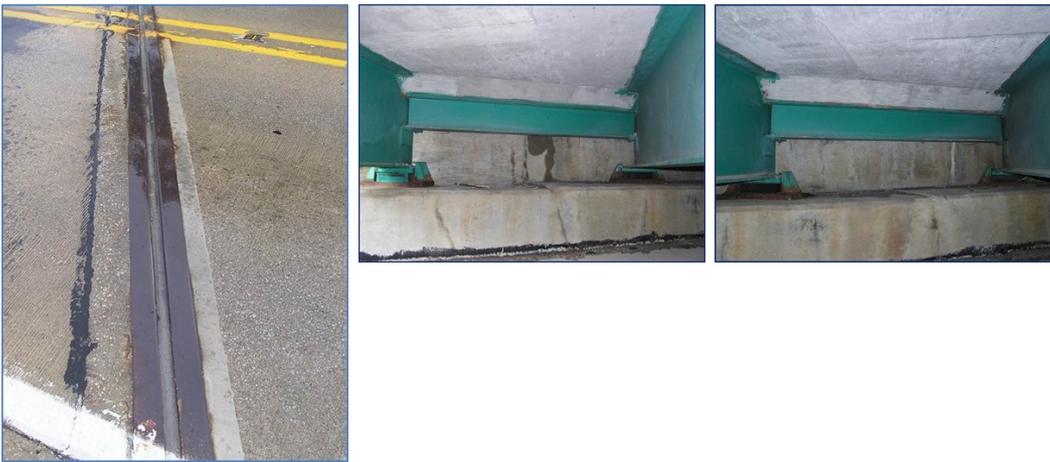
*Joints needed to be sealed between existing armor plates on the bridge*

- \* Application of Belzona® 4521 between the armor plates ,
- \* The intentional pinhole in the bay beneath Belzona application remains unchanged after 5-year service ,
- \* The bays on the east end of the bridge beneath Belzona application shows no signs of leakage after 5-year service ,

Application was carried out in accordance with the Belzona Know-How System Leaflet FPA-6 using approximately 200 cu in of Belzona® 4521.

Belzona solution has a long successful history providing long term performance. After 5 years in service, Belzona® 4521 application

was reviewed and showed no signs of leakage after several hours of hard rain. An intentional pinhole was added during installation to test failure resistance. Pinhole also remained unchanged after 5 years. A conventional silicone joint material installed on the other part of the bridge began leaking within 12 months of being placed.
