# BELZONA ENSURES LONG-TERM PROTECTION OF TUGBOAT HULL

ID: 4673

Hull plates of a 103' tugboat operated by the refinery

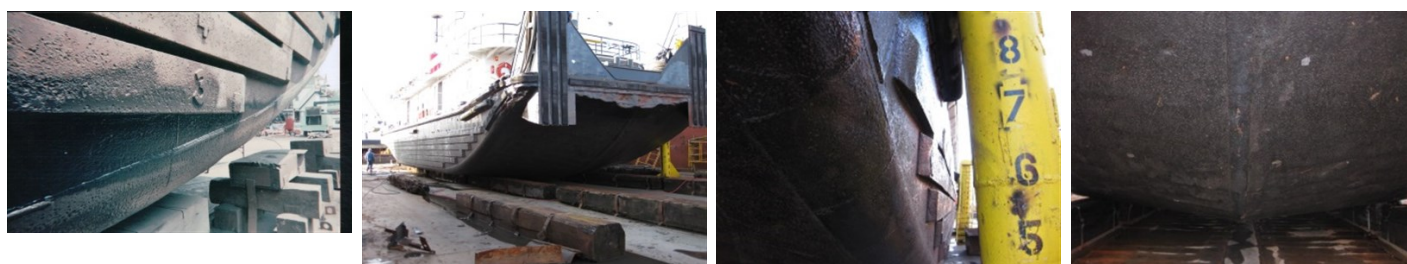
## Photograph Descriptions

Previous hull coating was 80% disbanded after 24 months. Hull plates were so badly pitted and corroded that abrasive blasting blew through in spots. The Refinery wanted a more durable hull coating.

- \* Image of hull plates pressure washed and in the process of abrasive blasting ,
- \* Hull plates coated with Belzona 5811 ,
- \* After 4 years in service, the coating is glossy and tightly adherent ,
- \* After 7 years in service, the coating is virtually unchanged ,

The application was carried out in accordance with Belzona Know-How System Leaflet SOS-2. Belzona 5811 was applied via a single-component airless spray.

Belzona has successfully proven to be a high cost-effective solution that has saved the Refinery \$168,000 and provided longer longevity than the conventional solvent coating. A 4-year inspection found the majority of the original coating in a perfect condition, still glossy and tightly adherent. During a 7-year inspection, the coating is virtually unchanged from the 4-year inspection

with both black and beige coats still present at full thickness. After a 9-year inspection, the application is still perfect and operating.
