# COMPLEX ROOF WEATHERPROOFED WITH BELZONA

ID: 4676

**Customer Location:** Boarding school, SW England  
**Application Date:** August 2013

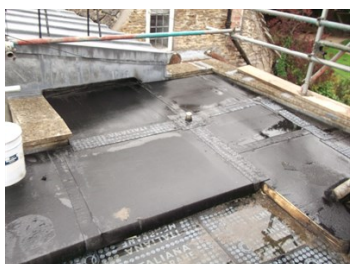
- \* Installation of new insulation boards ,
- \* New integrated gutters were created due to the increased thickness of insulation ,
- \* Completed application showing the complex geometry of the roof ,
- \* Completed application showing bonding to several different substrates. ,

The application was carried out in accordance with Belzona Systems leaflet RPA-8 after installation of new felt back insulation boards.
