# EFFLUENT CLARIFIER TANK REFURBISHED WITH BELZONA

Industry: Pulp & Paper

Application: FPA-Floor Problem Areas

Customer Location: Paper Mill, SW England

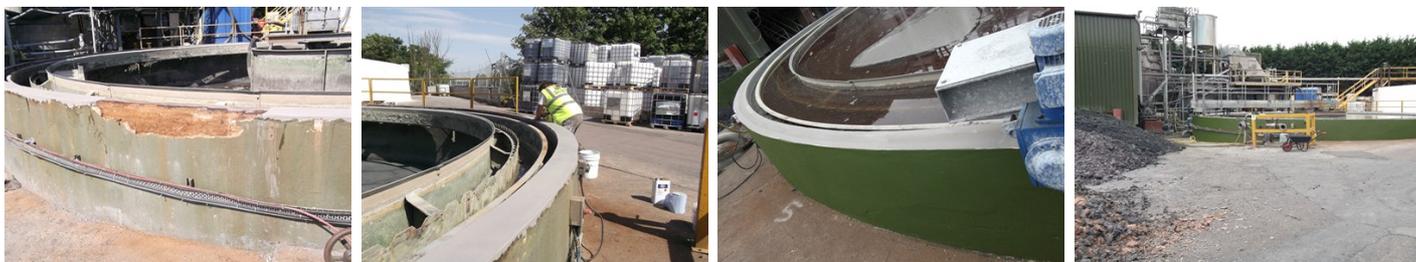
Breakdown of the concrete substrate due to water ingress and freeze thaw cycles had left the tank at risk of stoppages to production which the client could not afford. Traditional repairs or replacement would take too long and did not fit into the client's production schedule. The client only had a five day window which they could have the clarifier off line,

- \* Area of damage to concrete substrate ,
- \* Application of Belzona® 4131 ,
- \* Close up of completed application ,
- \* Completed application, \*note customer painted the tanks outside after coating with Belzona® 5151 to match corporate colour scheme. ,

Application was carried out in accordance with Belzona Know-How System Leaflets FPA-1 & FPA-6

This Belzona solution was chosen as the Belzona 4131 needed minimal cure time meeting the clients demanding schedule. The Belzona 5811 & Belzona 5151 were applied to extend the life of this crucial site asset by stopping any further water ingress into the substrate.
