BELZONA PROTECTS TANK ROOF WITH MINIMAL EFFORT

ID: 4723

Customer Location: Petrochemical Plant, UK.
Application Date: 2013

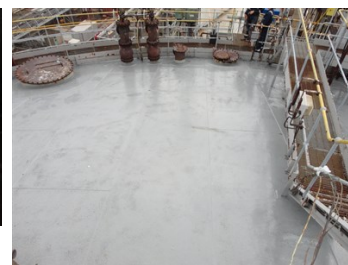
Roof of chemical tank was suffering severe corrosion but due to the highly explosive nature of the tanks contents, no hot works or mechanical tools could be used. The customer wanted an anti corrosion system that would bond with minimal preparation and be flexible enough to move with the tank. As the whole roof is subject to regular inspections, they also wanted a system that could offer good traction under foot on this domed surface.

- * Chemical tank of 29m height ,
- * Corroded domed roof ,
- * Application of Belzona® 5831 with Belzona® 9211 in the top coat ,
- * Phase 1 completed ,

Application was carried out in accordance with Belzona Know-How System Leaflet TCC-5. Preparation was limited to hand wire brushing. 2 coats of Belzona 5831 were applied with Belzona® 9211 broadcast into the surface to create a positive grip..

Phase 1 of this project on the main roof dome covered 540m2 and included many pipes and gantry legs. All were prepared with

hand tools to eliminate the possibility of sparking. Belzona 5831 offered a solvent free solution with excellent adhesion. With the Belzona 9211 incorporated, it afforded assured grip, even in wet conditions. The client was delighted with the results and is due to repeat the application on other parts of the site.
