BELZONA PROTECTS TANK ROOF WITH MINIMAL EFFORT

ID: 4723

Customer Location: Petrochemical Plant, UK.

Chemical Tank Roof.

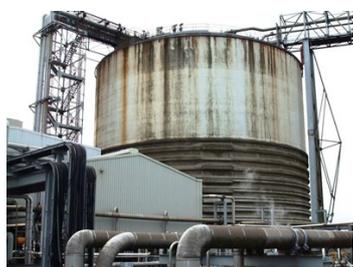
- * Chemical tank of 29m height ,
- * Corroded domed roof ,
- * Application of Belzona® 5831 with Belzona® 9211 in the top coat ,
- * Phase 1 completed ,

Application was carried out in accordance with Belzona Know-How System Leaflet TCC-5. Preparation was limited to hand wire brushing. 2 coats of Belzona 5831 were applied with Belzona® 9211 broadcast into the surface to create a positive grip..
