# COMPLETE ZONE SAFETY WITH BELZONA

Customer Location: Waste Water Treatment Plant, Teesside, UK

Application: FPA-Floor Problem Areas

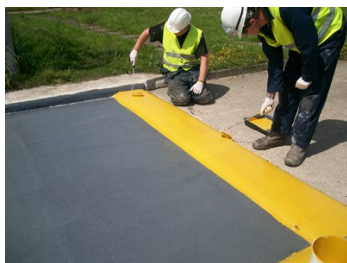
Both road areas needed a chemical lining that would be resistant to repeated splashes and spills. In addition, the areas had to have good traction for the lorries that regularly visited the plant.

- \* Unloading zone before ,
- \* Application in Phosphoric Acid zone ,
- \* Completed Phosphoric Acid zone in Belzona® 4311 ,
- \* Completed Sodium Hypochlorite zone in Belzona® 5811 ,

Application was carried out in accordance with Belzona System Leaflets FPA-1,3, 4 and 6. Concrete repairs were made with Belzona 4131. Areas were coated with either Belzona 5811 against Sodium Hypochlorite or Belzona 4311 against Phosphoric Acid, Belzona 9211 was scattered in the final coat for traction. Expansion joints were filled with Belzona 2111. Finally Belzona 5231 in yellow was used as a demarcation colour on edges and ramps.
