# BELZONA USED IN WINDMILL REFURBISHMENT

Industry: Buildings & Structures  
Application: RPA-Roof Problem Areas  
Substrate: Wood  
Products: \* Belzona 3111 (Flexible Membrane) ,

Customer Location: Windmill, Buckinghamshire, UK  
Application Date: April 2013

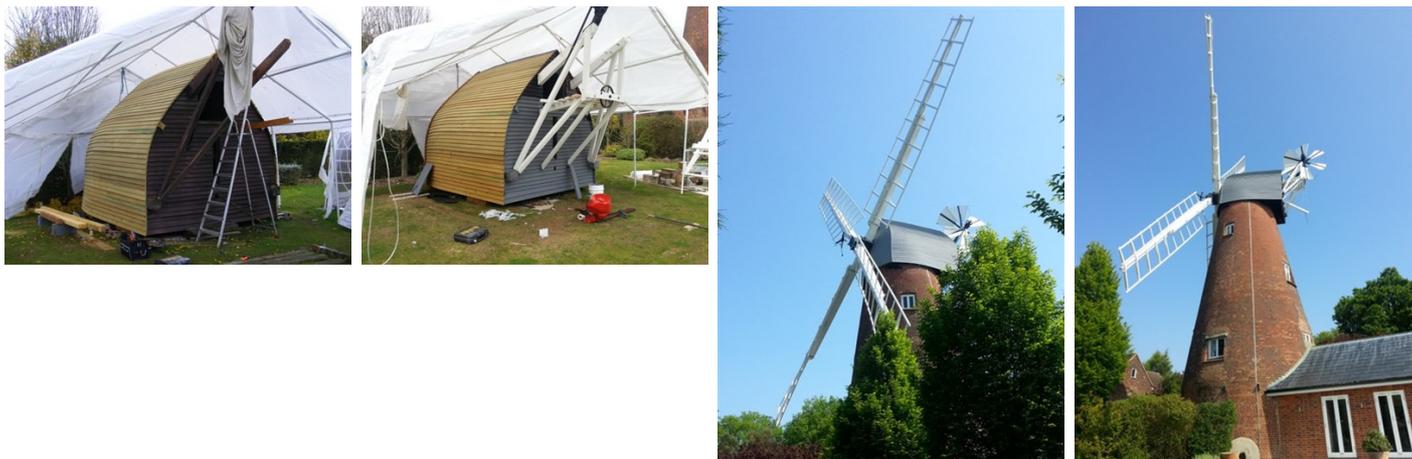
With the exposed nature of a windmill it was essential to provide long-term waterproofing.

- \* The cap on the ground with freshly replaced timbers ,
- \* First layer of Belzona 3111 being applied ,
- \* & 4. Finished application with cap fitted back in place ,

Once the sails had been removed the wooden cap was taken down and work could commence to replace any rotten or damaged timber. Upon completion of the structural work the fully reinforced Belzona 3111 system was applied in accordance with Belzona System Leaflet RPA-1. With all the overlapping timbers it required the patience of a craftsman to carefully lay the reinforcing sheet into the Belzona 3111 to achieve a wrinkle free finish with the sheet closely following the substrate profile.
