# BELZONA SEALS & WEATHERPROOFS ASBESTOS SCHOOL ROOF

Customer Location: School, Galashiels, Scotland  
Application Date: July 2013

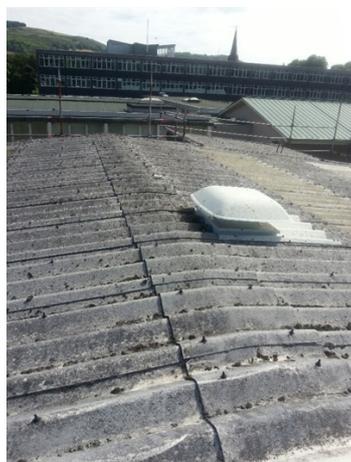
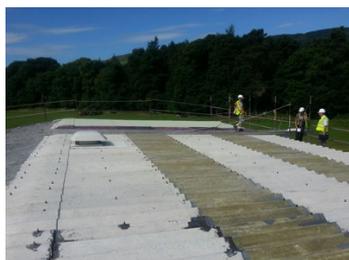
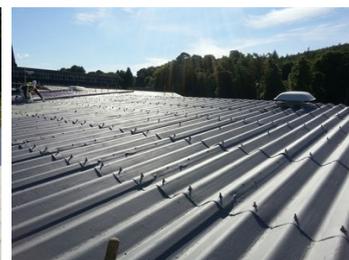
\* 1. Before power wash 2. After surface preparation 3. Applying the Belzona 3111 Membrane system 4. Finished section of roof ,

Application was carried out in accordance with Belzona System Leaflet RPA-1. The roof was power washed with a special filter system used to collect the 'run off'. Belzona 3111 system was then applied to the entire roof area.
