# BELZONA SEALS & WEATHERPROOFS ASBESTOS SCHOOL ROOF

ID: 4731

Customer Location: School, Galashiels, Scotland  
Application Date: July 2013

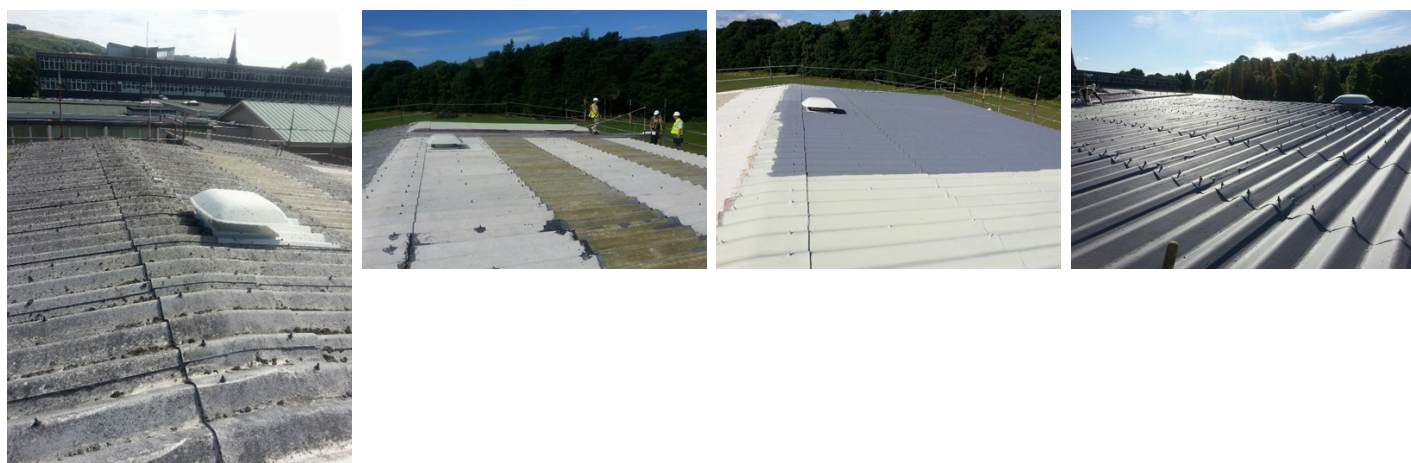
The roof had been leaking for years. Patch repairs had been tried but the water always found another way in. Client requested a complete and long term solution.

\* 1. Before power wash 2. After surface preparation 3. Applying the Belzona 3111 Membrane system 4. Finished section of roof ,

Application was carried out in accordance with Belzona System Leaflet RPA-1. The roof was power washed with a special filter system used to collect the 'run off'. Belzona 3111 system was then applied to the entire roof area.

Removal and replacement of the roof would have run into hundreds of thousands of pounds. Belzona system was able to provide a long term water/weather proofing solution whilst encapsulating the corrugated asbestos.
