# AERATION CHANNEL LEAKS REPAIRED WITH BELZONA

ID: 4733

Customer Location: Sewage Works, Kent

Leaking joints in sewage aeration channel

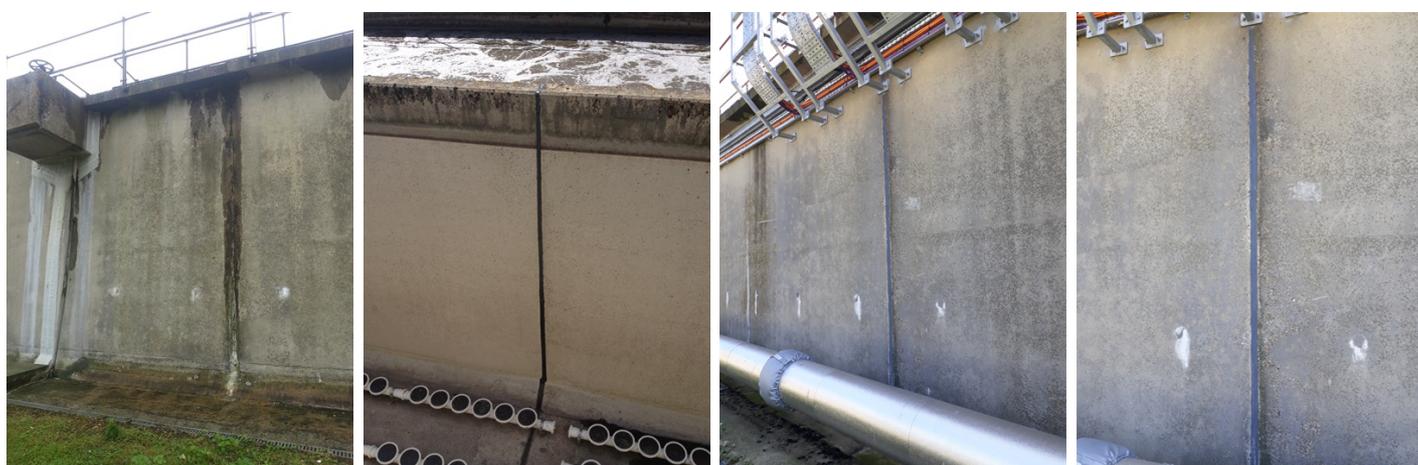
## Problem

- \* External view of leaking joints and previous attempts to stop leaks ,
- \* Repaired Movement joint 2013 ,
- \* Movement joint still going strong after revisiting in 2019 compared to alternative solution. ,
- \* Movement joint still going strong after revisiting in 2019 ,

All joints were repaired in accordance with Belzona Know-How System leaflet WPA-3.

The Belzona repairs were carried out over two days and the tank was reinstated 2 days later. The aeration lane was only out of action for 5 days. After a month of being in operation there are still no leaks.

Site was revisited in 2019 showing no damage or wear on the repairs only leaks were shown on alternative solution.
