BELZONA PROTECTION TO FLANGE EDGES ON GLASS LINED PROCESS VESSELS

ID: 4735

Industry: *Chemical & Petrochemical*
Application: *TCC-Tanks and Chemical Containment Areas*
Substrate: *Mild Steel*
Products: ** Belzona 1392 (Ceramic HT2),*

Customer Location: *Chemical Plant, South Wales, UK*
Application Date: *2012*

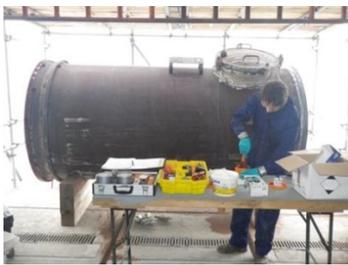
- * Preparation of habitat, product and equipment prior to coating procedure ,
- * Substrate condition following grit blast preparation ,
- * Completion of first coat colour coded grey ,
- * Completion of second coat colour coded red ,

Application was carried out in accordance with Belzona System Leaflet TCC-3. Specific attention had to be given to the grit blasting and application to ensure damage was not caused to glass lining. The coating must align perfectly to the full circumference of the glass lining in the vessel.

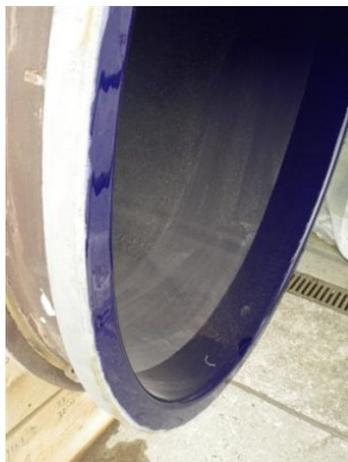
External flange edge corrosion preventing correct sealing of the vessels.
