# BELZONA UPGRADES SCHOOL POTWASH FLOOR

ID: 4737

Customer Location: College, Sussex, UK  
Application Date: 2012

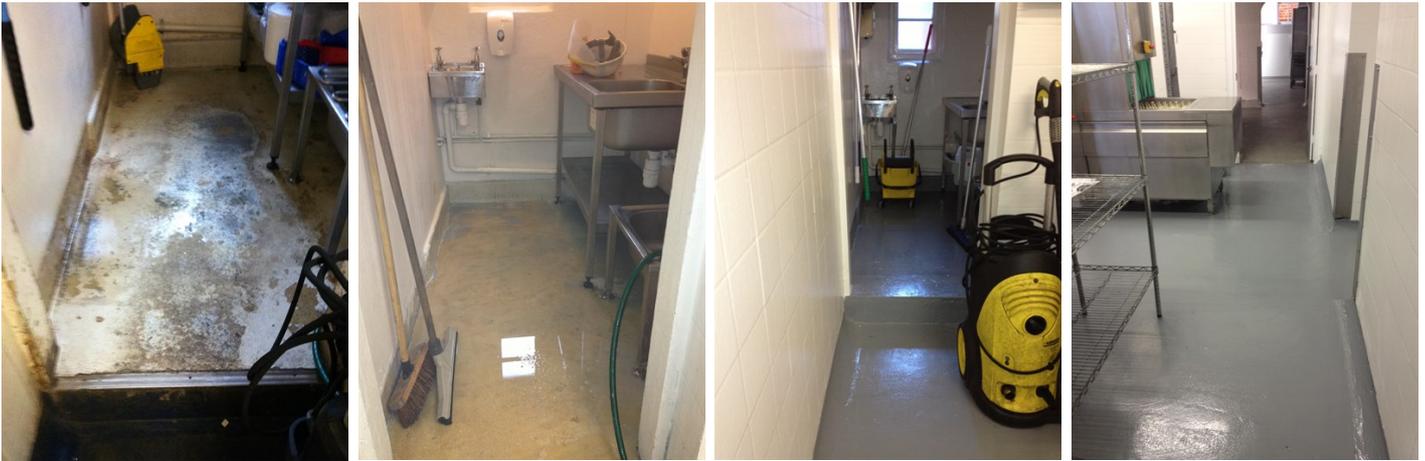
\* 1. The pot wash floor before work commenced 2. After being cleaned and grit blasted 3. The pot wash floor after application 4. The loading/sorting area also coated ,

The existing floor coating had only been down 6 months and was failing, trapping dirt and grease and generally not very hygienic. The Belzona solution was selected as it has proven track record, could easily withstand the activity of washing 1000's of dishes a day and that when applied it doesn't give off an odour. Adding aggregate allowed a non slip surface to be created ensuring safety of the staff on what would otherwise be a very slippery floor

Application carried out in accordance with Belzona System Leaflet FPA-3 and FPA-8. The Belzona 9231 (Surefoot Aggregate) was broadcast on the surface of the Belzona 5811 to create a non-slip surface.
