# BELZONA SOLUTION FOR SPALLED VICTORIAN LINTEL

ID: 4752

Customer Location: Shoe manufacturer, South West England  
Application Date: October 2013

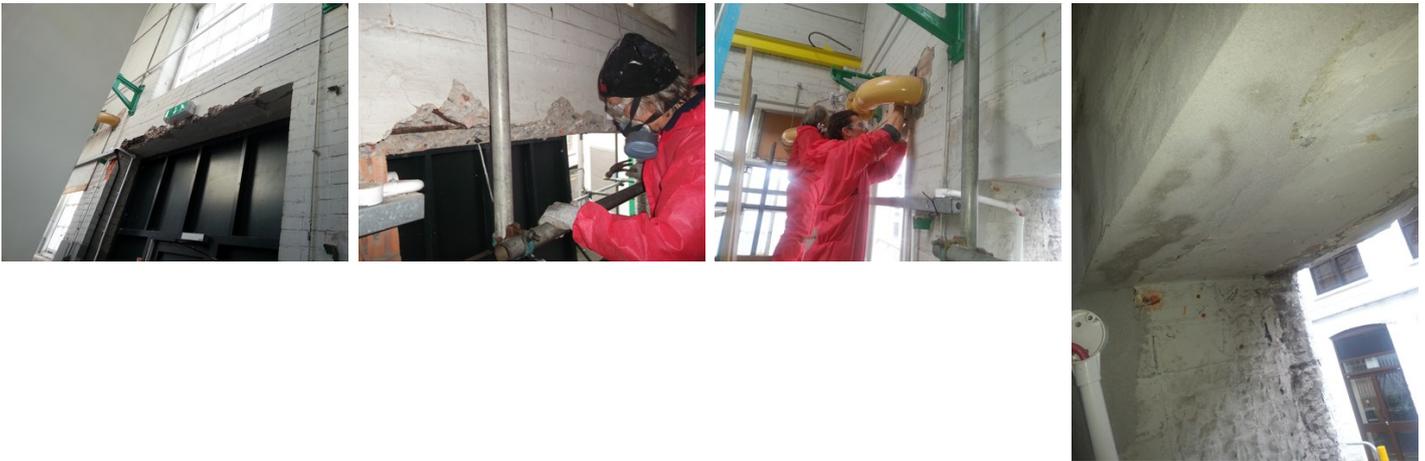
The lintels of the main door and windows had suffered severe deterioration. Carbonation of the concrete had allowed rebar corrosion leading to spalling of the concrete. The Belzona solution was selected due to the materials lightweight, non-porous and high adhesion together with its ability to complete the repair quickly and with minimal disturbance.

- \* View of the main lintel at initial inspection ,
- \* Preparation of the main lintel ,
- \* Application being carried out to the adjacent window lintel showing the corner of the main lintel with the application completed ,
- \* Close up of the completed application on the main lintel ,

The works were carried out in accordance with the Belzona Systems leaflet WPA-4.

Due to the age of the building and time constraints, replacement of the lintels was not an option. The Belzona solution was carried out over two days and at a fraction of the cost to replace.
