# BELZONA PROTECTS HIGH TEMPERATURE ISOLATION SPOOL

Industry: Oil & Gas  
Application: VPF-Valves, Pipes and Fittings  
Substrate: Stainless Steel  
Products: \* Belzona 1391 (Ceramic HT) ,

Customer Location: Off-shore Production Company, Canada  
Application Date: November 2009

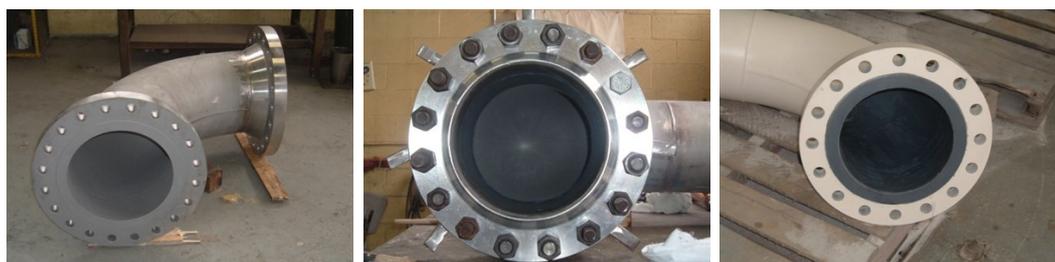
The original rubber lining and conventional coatings were unable to handle these adverse conditions and failed within a very short space of time.

- \* Section of piping after surface preparation had been completed ,
- \* A former and machined shims in place to create new flange face ,
- \* Completed application ,

The application was carried out in accordance with Belzona Know-How System Leaflet VPF-3. After the surface was prepared, a former and machined shims were used to create a new spiral wound flange face. After the flange face forming was complete, the internal surfaces of the pipe elbow had been coated with Belzona 1391.
